Client:
GALWAY HARBOUR COMPANY

Project:
GALWAY HARBOUR EXTENSION

Title:
CONSTRUCTION SEQUENCING SHEET 6 OF 9

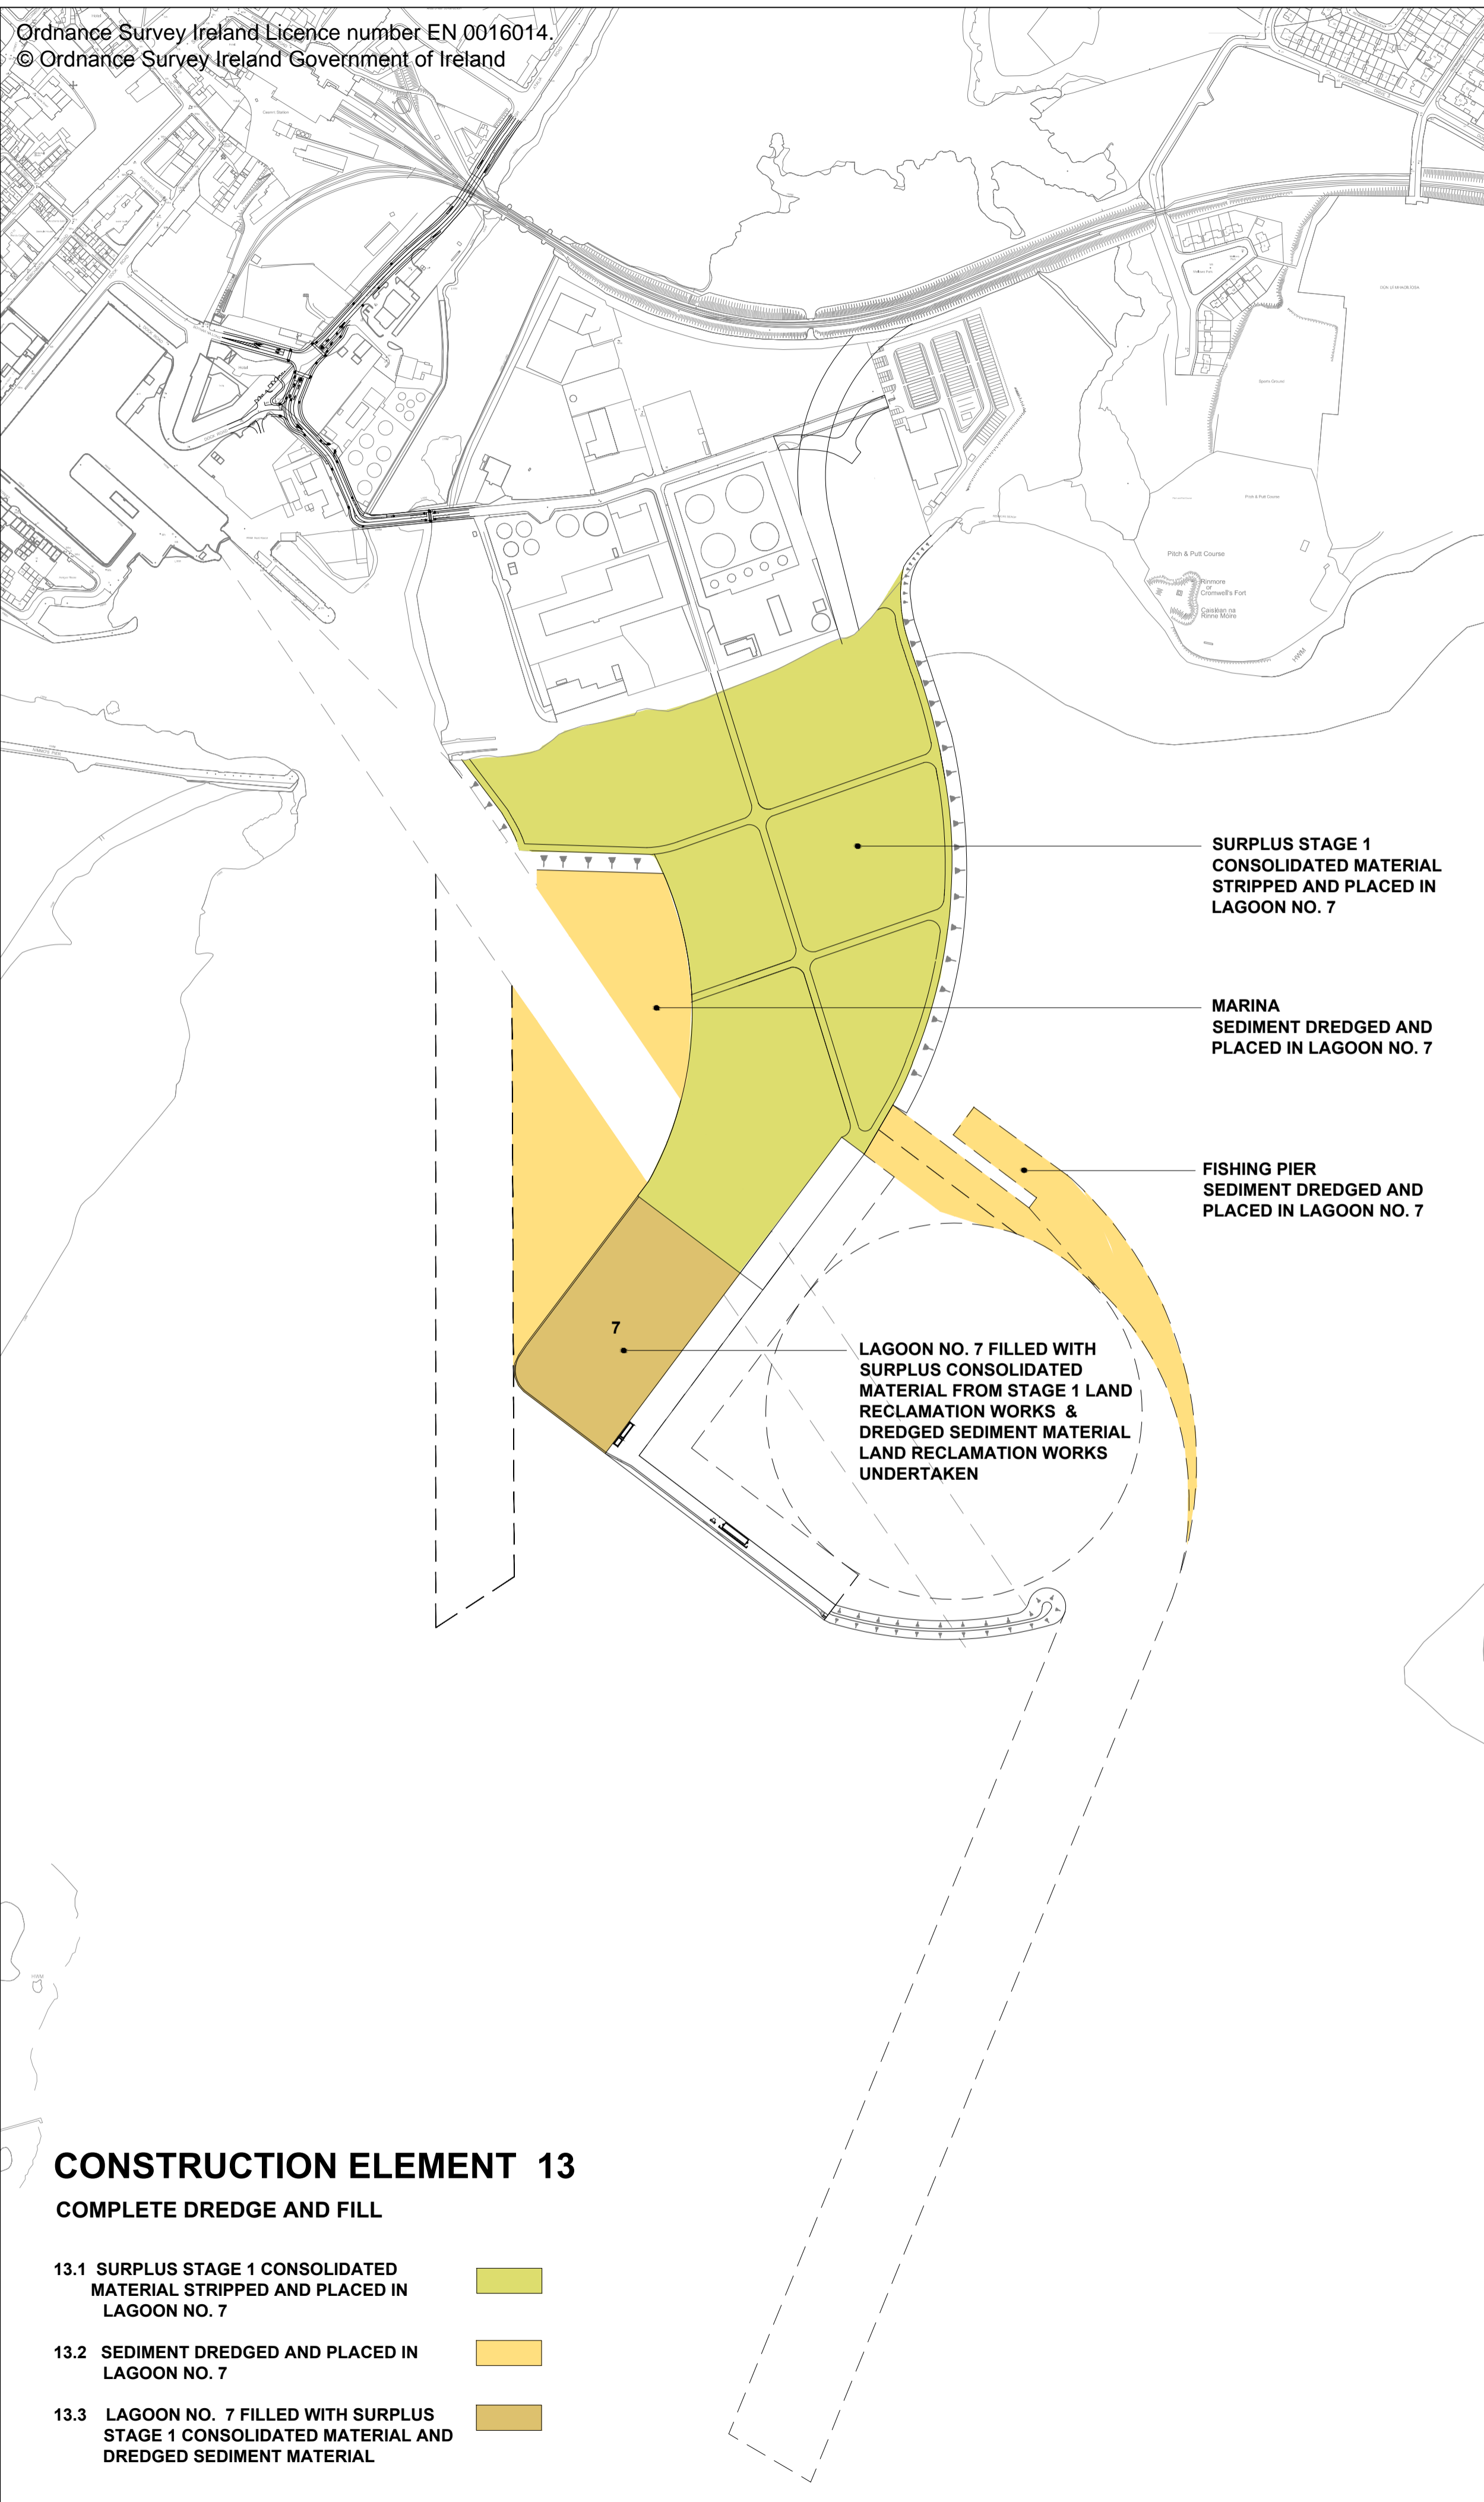
CONSTRUCTION ELEMENT 13
COMPLETE DREDGE AND FILL

- 13.1 SURPLUS STAGE 1 CONSOLIDATED MATERIAL STRIPPED AND PLACED IN LAGOON NO. 7
- 13.2 SEDIMENT DREDGED AND PLACED IN LAGOON NO. 7
- 13.3 LAGOON NO. 7 FILLED WITH SURPLUS STAGE 1 CONSOLIDATED MATERIAL AND DREDGED SEDIMENT MATERIAL

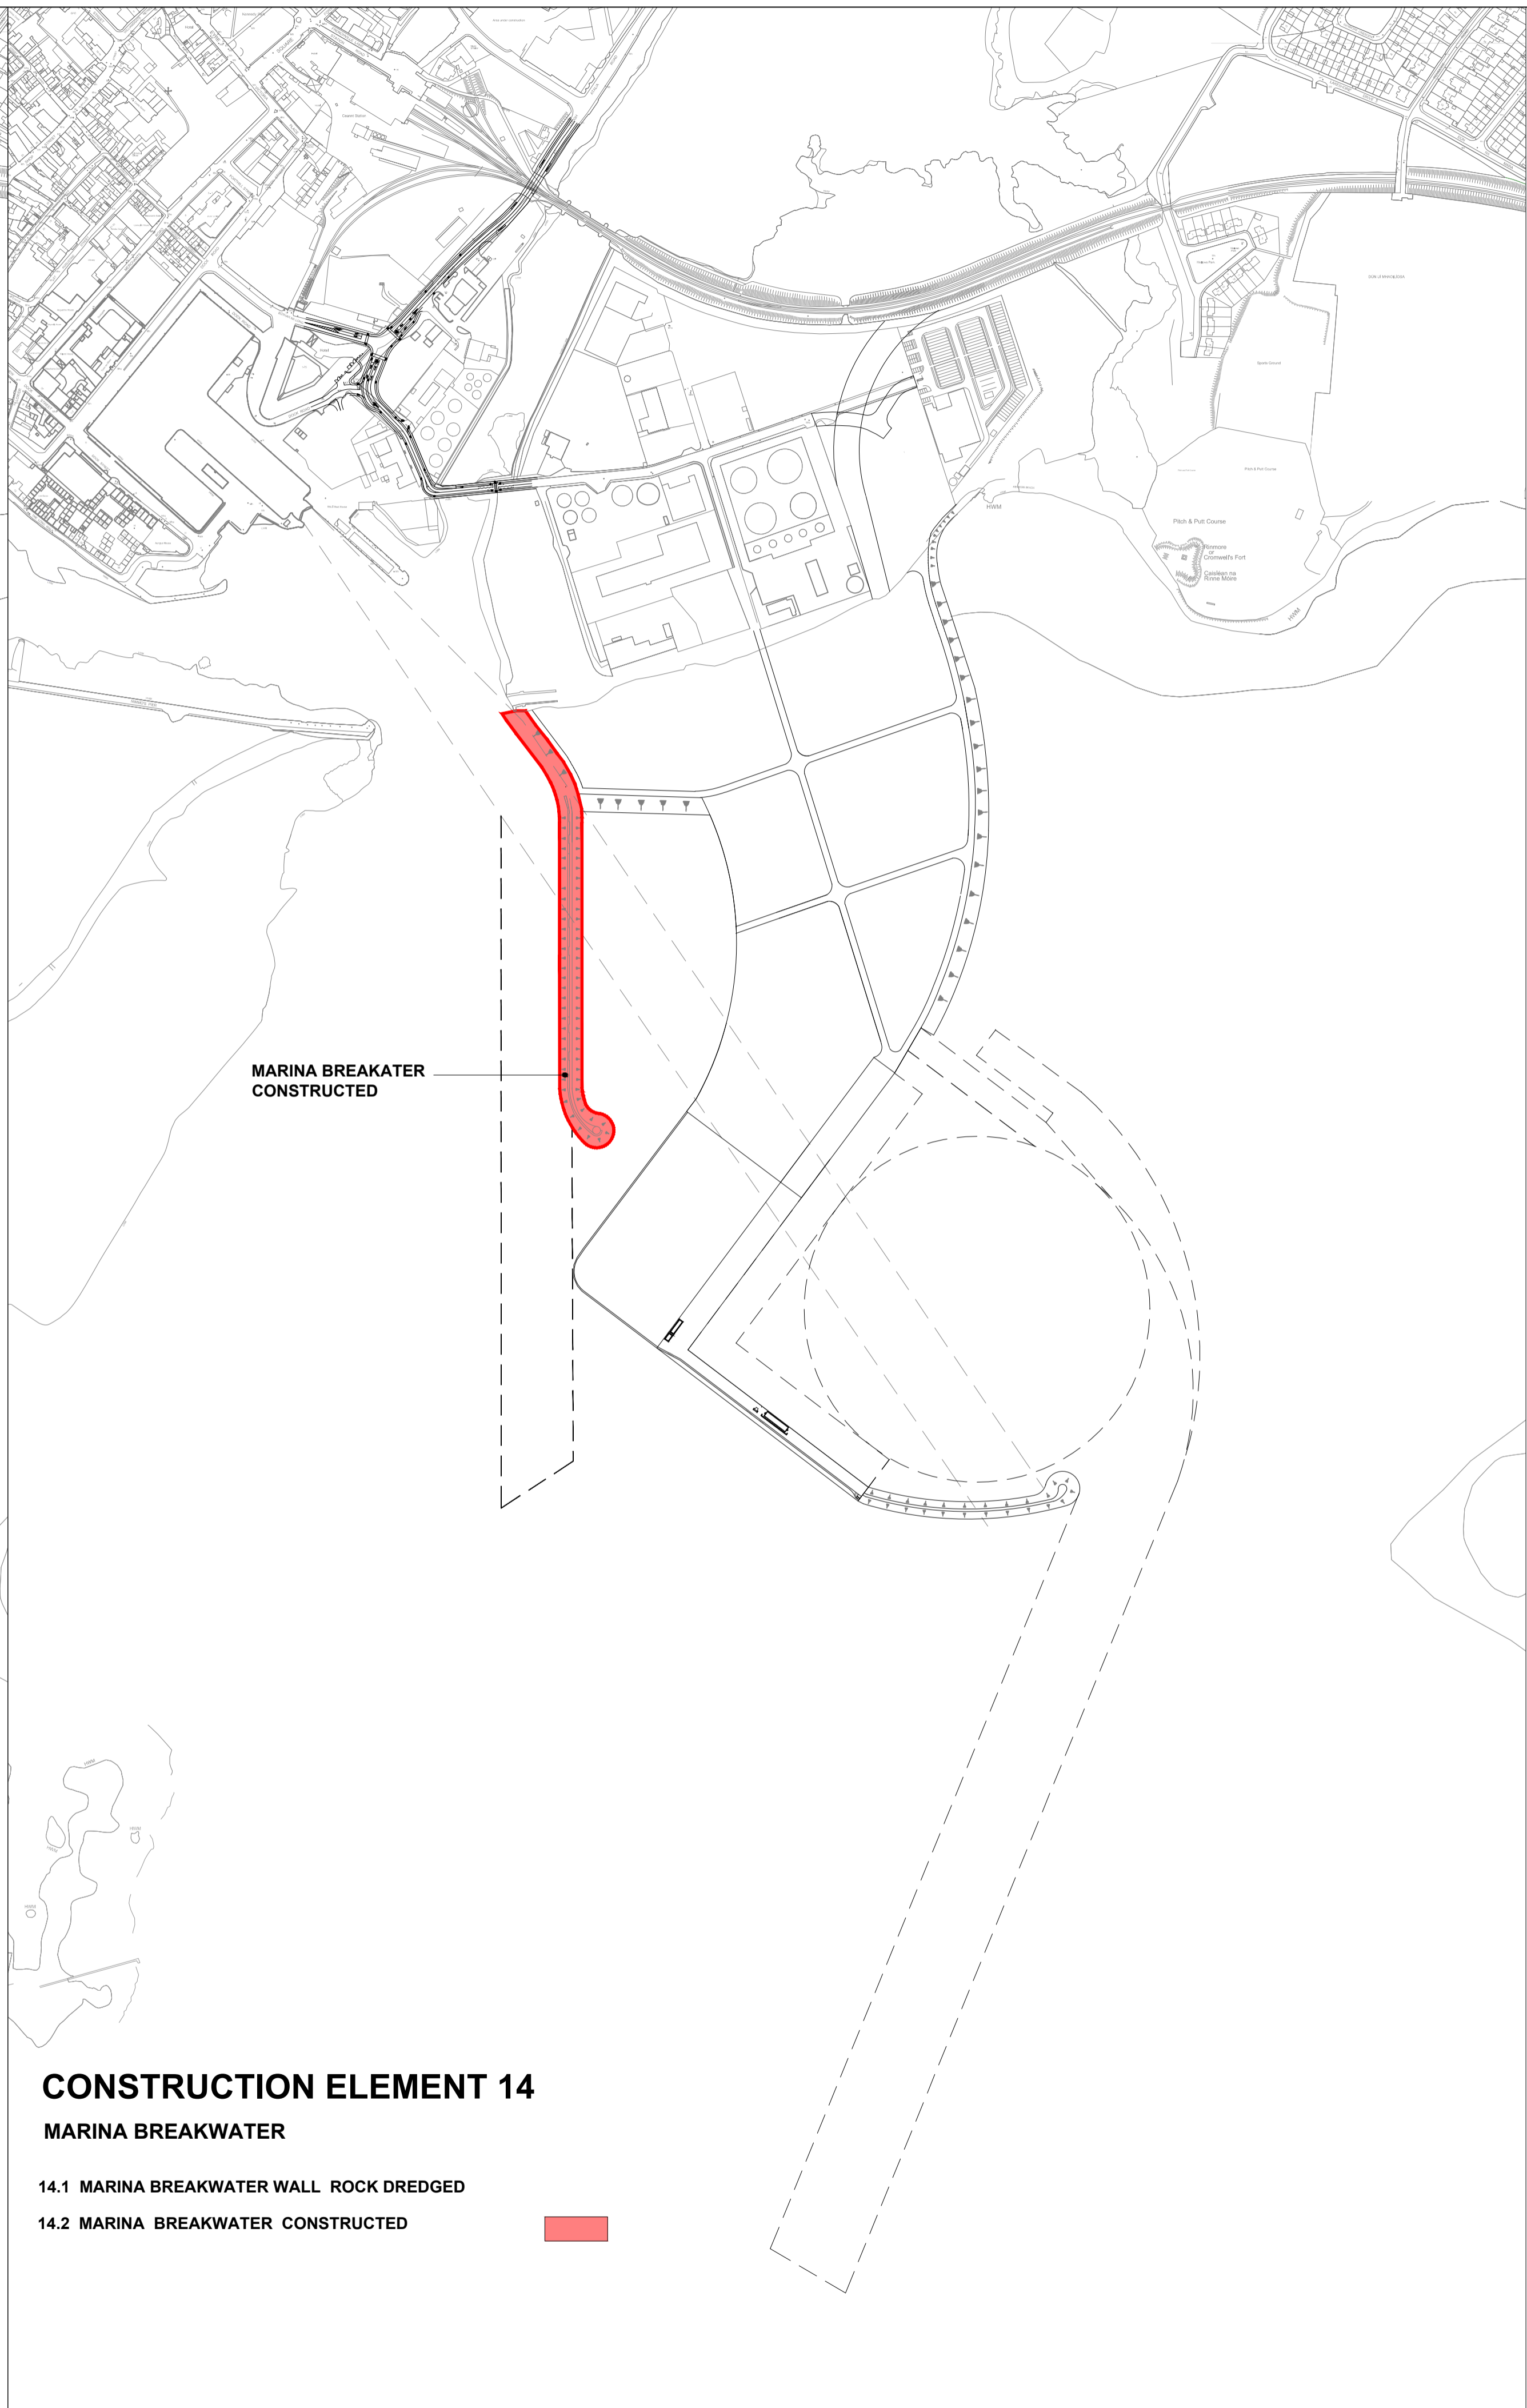
CONSTRUCTION ELEMENT 14
MARINA BREAKWATER

- 14.1 MARINA BREAKWATER WALL ROCK DREDGED
- 14.2 MARINA BREAKWATER CONSTRUCTED
